RENGSTORFF PARK MASTER PLAN

Capital Improvement Project 09-24

Adopted March 4, 2014

Rengstorff Park Inventory

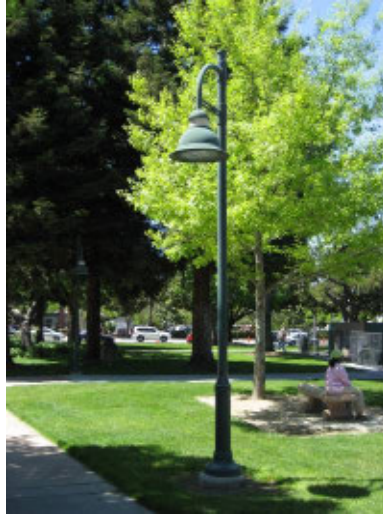
This is the primary light fixture type for the majority of the park. The fixtures appear to be in good condition and functioning properly. Some fixtures are in need of cleaning.

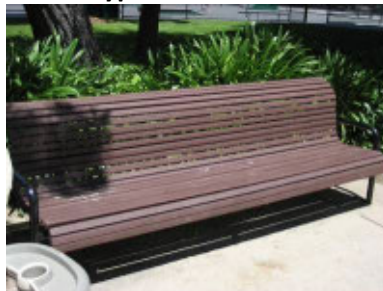
Bench Type A is a wood slat bench with metal support structure approximately 6 feet long. The painted wood slats are in relatively good condition but in some cases require repainting.

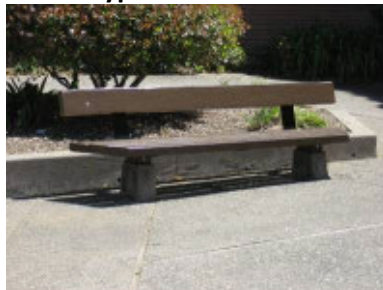
F2.B

Bench Type B consists of a painted wood bench with wood back supported by concrete and steel structure. These benches appear to be older and are still functioning well but in some cases need refinishing.

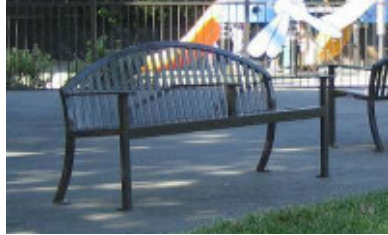
F2.C

Bench Type C is a lightweight powder coated metal bench bolted to the paving surface. These benches appear to be a more recent addition to the park and are in good condition.

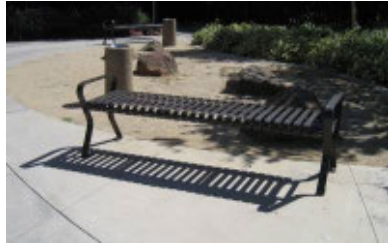
F2.D

Similar in many aspects to bench type C, this bench is a powder coated metal bench but does not have a back.

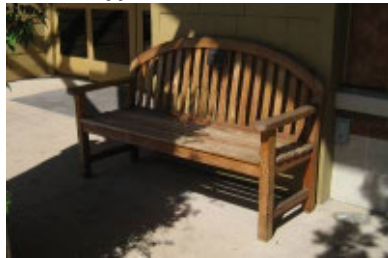
F2.E

Bench Type E is a free standing all wood bench with a natural wood finish. The benches are in good condition, but due to the natural wood finish, these benches are better suited for areas sheltered from the weather and direct sun.

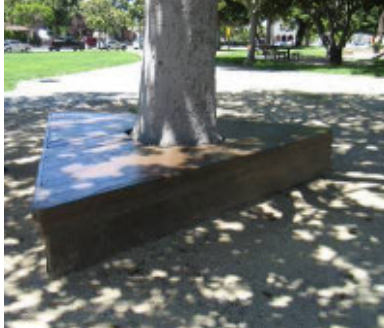
F4 **Seating (at Trees)**

The seating area around the trees is a triangular shaped, painted, wood framed structure that is in good condition.

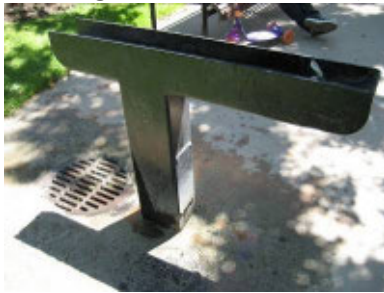
The drinking fountain at the tot lot is functioning but appears to be leaking and is in need of repair. This fountain also does not appear to meet accessibility requirements.

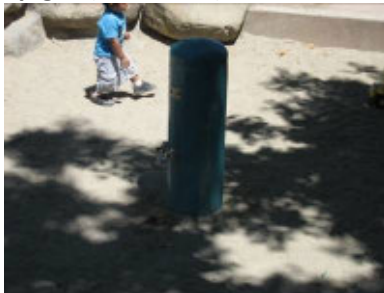
The hose bib water spigot at the tot lot appears to not be working properly. The purpose of this spigot is unknown.

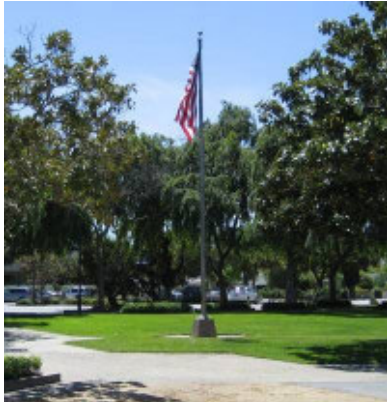
F7 Flagpole (at Community Center)

The flagpole near the Community Center is located on a small slab within a larger lawn area, making it inaccessible for the disabled. Visibility of the flagpole is limited due to the surrounding tall trees.

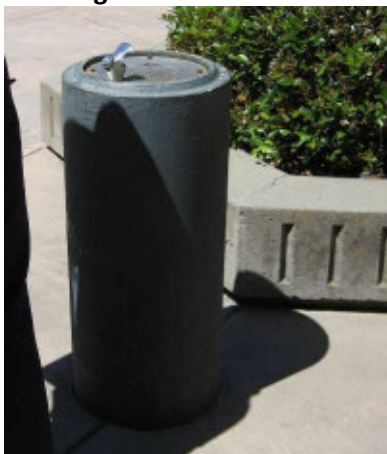
This type of drinking fountain is not accessible for the disabled. They may be original to the park from the early 1960's and appear to be showing their age and wear.

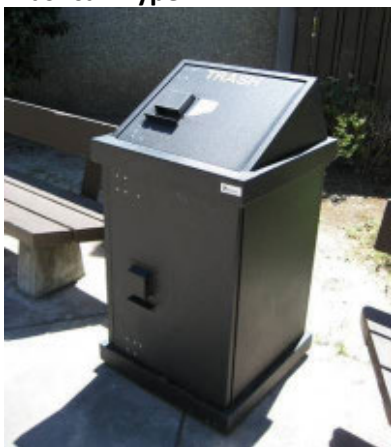
F9.A Trashcan Type A

This type of trashcan appears to be an accessible, animal resistance trash container. They also appear to be recent additions to the park given their

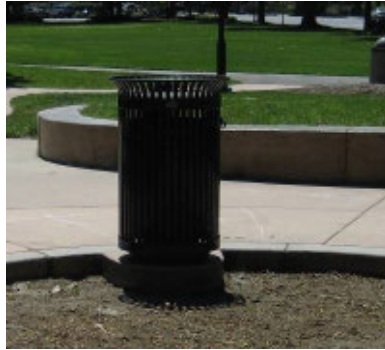
F9.B

Trashcan type B is a decorative metal can that appears to be relatively new and well maintained. This type of can makes up the majority of the park's trashcans along with trashcan type F9.C.

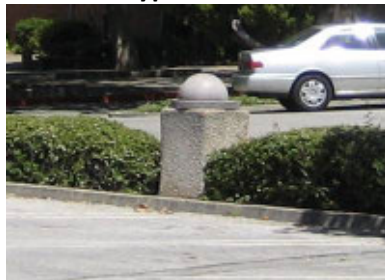
F9.C

Trashcan type C may be original to the park from the early 1960's and appear to be showing their age and wear. This element consists of a concrete base and plastic top.

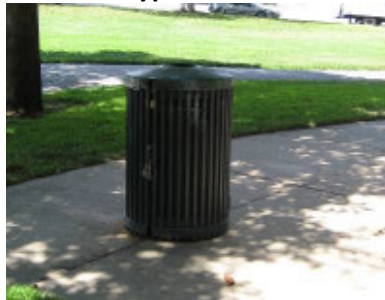
F9.D

Similar in appearance to trashcan type B, type D is a decorative metal trashcan. This trashcan type shows wear and is likely older than many of the trash receptacles used on site.

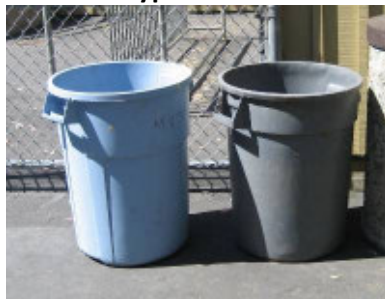
F9.E

The rubber trash containers were only observed near the Tennis Courts. The use of these containers as different from the adjacent trashcan was not discernable.

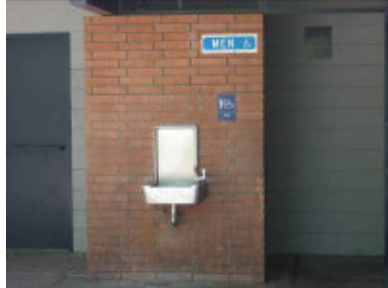
F10 Drinking Fountain

The park features several wall-mounted drinking fountains. Further investigation is needed to determine if all locations meet accessibility requirements.

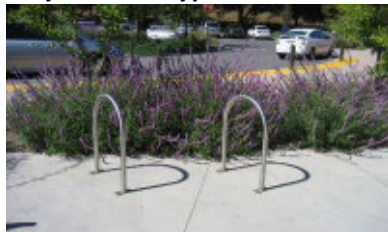
F11.B Bicycle Rack Type B

Bicycle rack type B is located near the new Senior Center. Each 'U' in the rack assembly can accommodate secure parking for up to four bicycles. These racks are new and well maintained.

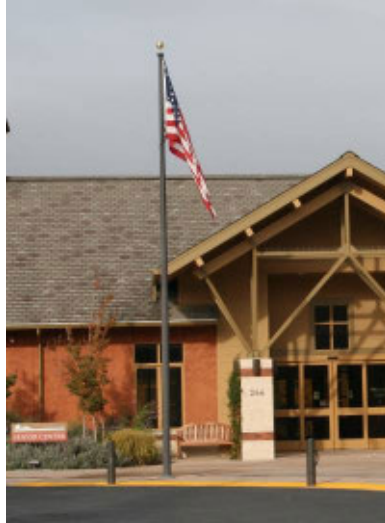
F14 Flagpole (at Senior Center)

The flagpole at the Senior Center is located directly off the entry drive and drop-off area. It is highly visible and well maintained.

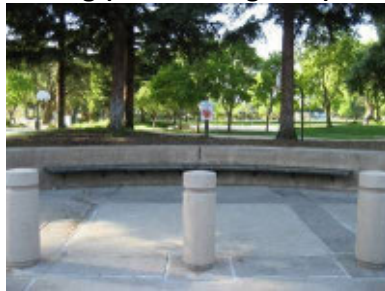
Constructed during the renovation of the Barbeque Area in 1992, this seating element shows considerable signs of wear possibly from unintended uses (i.e. skateboarding, BMX biking, etc.)

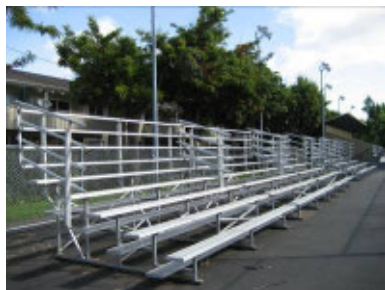
F18 Bleachers

There are two free standing bleach structures near the tennis courts. Both appear to be in good condition and well maintained.

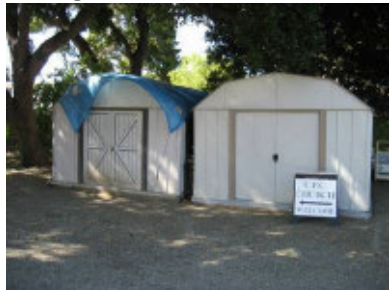
The Rock Church parking lot holds two portable storage sheds. Although the age of the sheds is unknown, one has a tarp over its roof, which may mean there are issues with leaks. It is unknown if these structures will remain on the site once the church vacates the property.

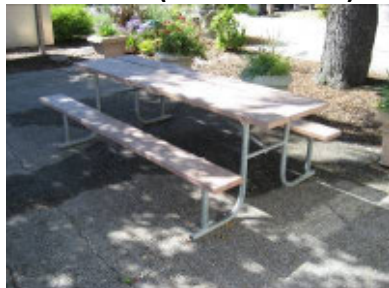
The picnic tables at the exterior of the Teen Center are showing signs of age and wear, but appear to be functional. None of the picnic tables allow for disabled access.

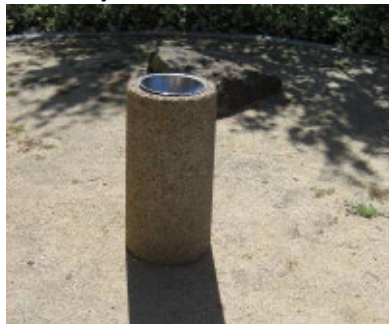
F21

The exterior areas near the Senior Center feature concrete ash trays. These are new site accessories and appear to be well maintained and functional.

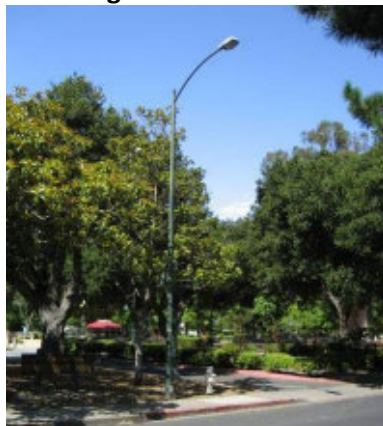
F25

The park features several street lights along Rengstorff and Crisanto Avenues.

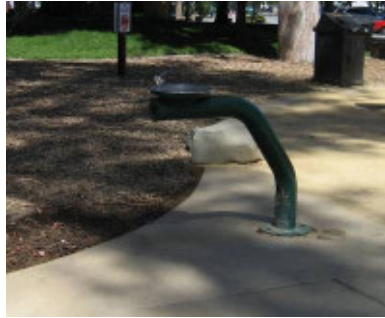
F29

The drinking fountain in the Family Picnic Area appears to be accessible.

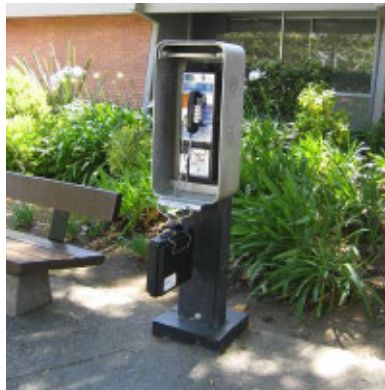
F30

Rengstorff Park features one public telephone located near the Community Center entrance. The phone appears to be accessible and functional.

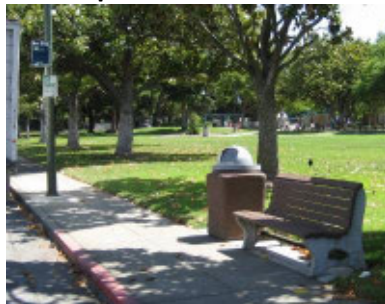
F31

Rengstorff Avenue has one Valley Transit Authority (VTA) bus stop direct in front of the park. This stop serves the route 40 southbound, La Avenida and Indigo to Foothill College.

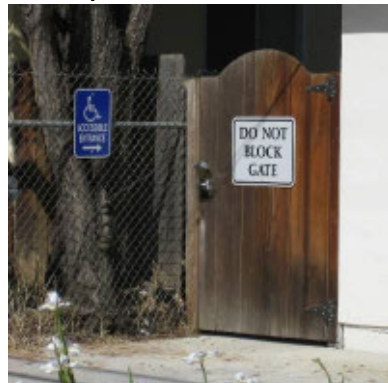
S49

Accessible Entry (at Teen Center)

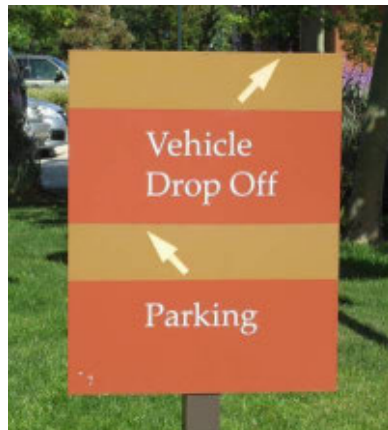
S51

Vehicular Circulation

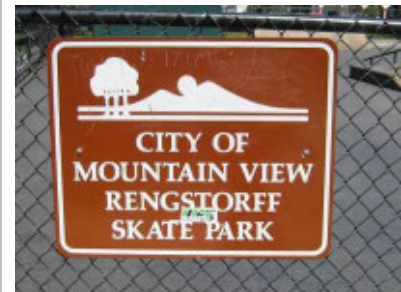
S52

Skate Park

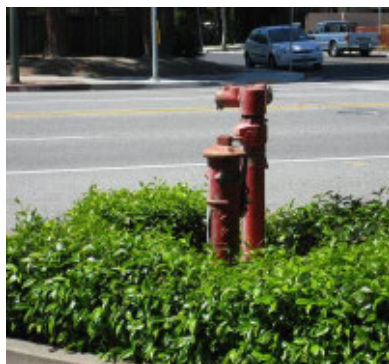
M1

Fire Utilities

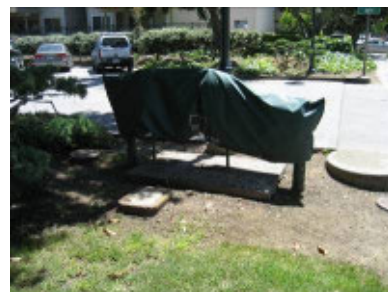
M2

Water Back Flow Preventer

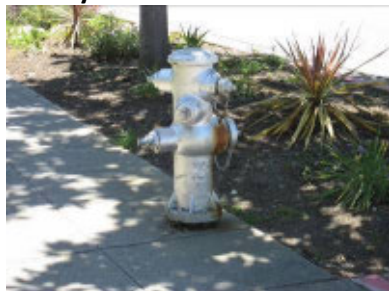
M3

Fire Hydrant

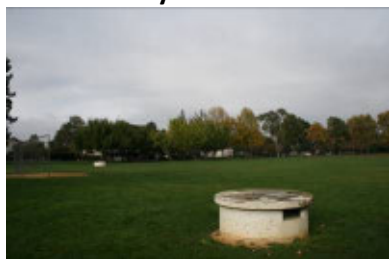
M5

Hetch Hetchy Vents

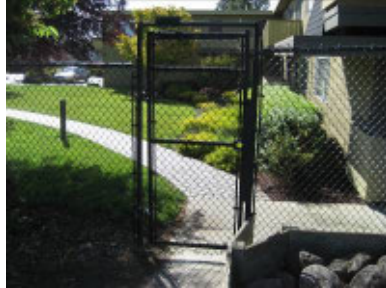
M7.A

**Gate to Adjacent Residential
Developments
Type A (at Rengstorff Park)**

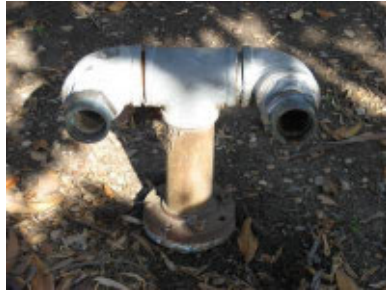
M8

Water Connection

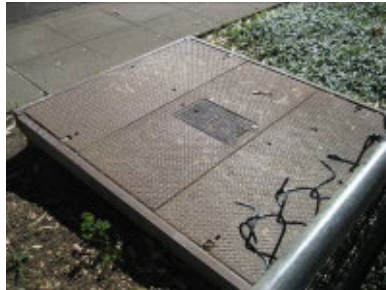
M10

Water Vault

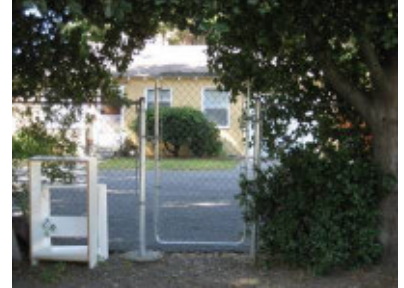
M7.B

**Gate to Adjacent Residential
Developments
Type B (at Rock Church)**

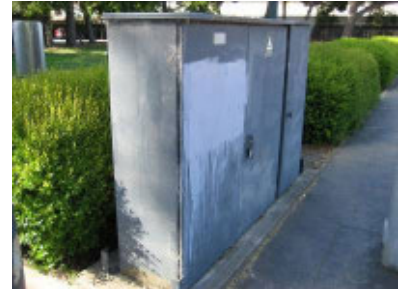
M11

**Electrical Equipment (at Dog
Training Area)**

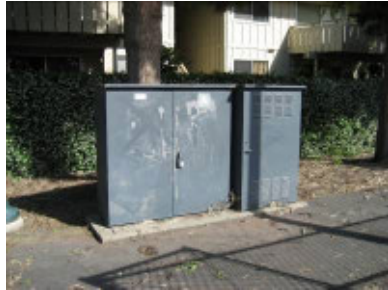
M12 **Electrical Equipment (at Tennis Grandstand)**

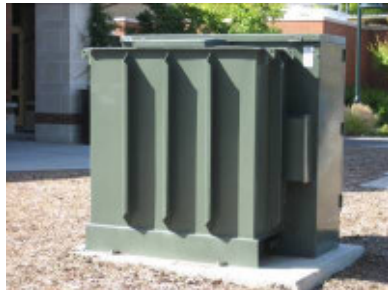
M14 **Electrical Equipment (at Senior Center)**

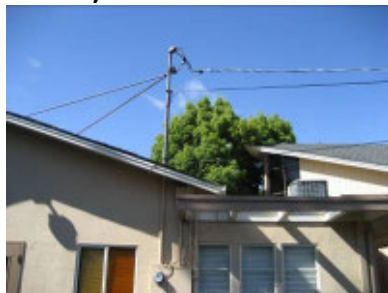
M16 **Electrical Service (at Rock Church)**

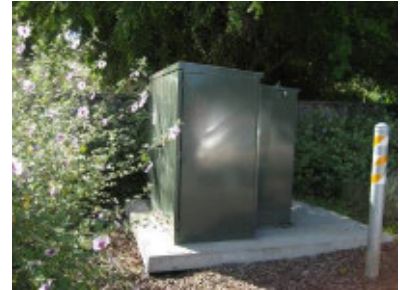
M13 **Electrical Equipment (at Teen Center)**

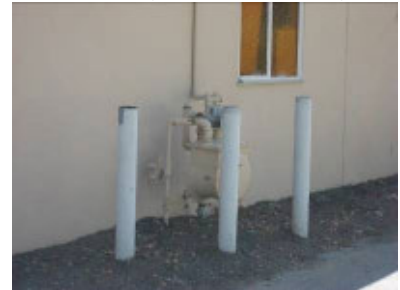
M15 **Gas Meter (at Rock Church)**

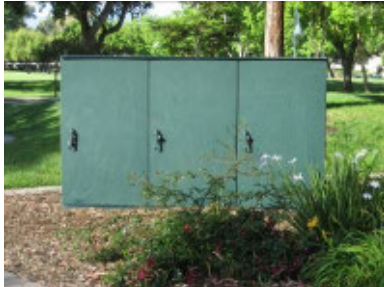
M18 **Electrical Equipment (at Basketball Courts)**

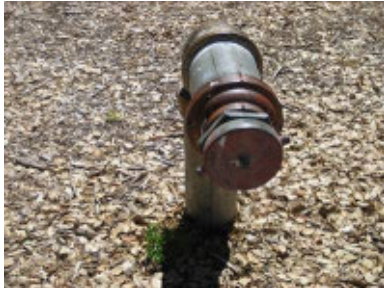
M20 **Water Connection (at Aquatics Building)**

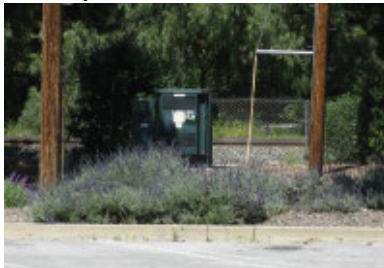
M22 **Electrical Equipment (at Train Tracks)**

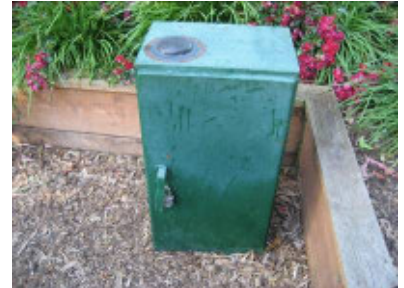
M19 **Electrical Equipment**

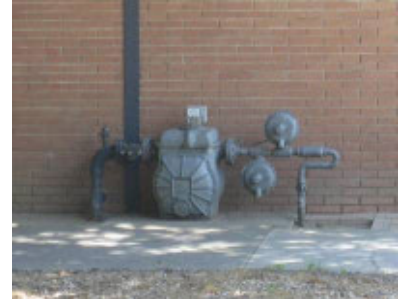
M21 **Gas Meter (at Aquatics Building)**

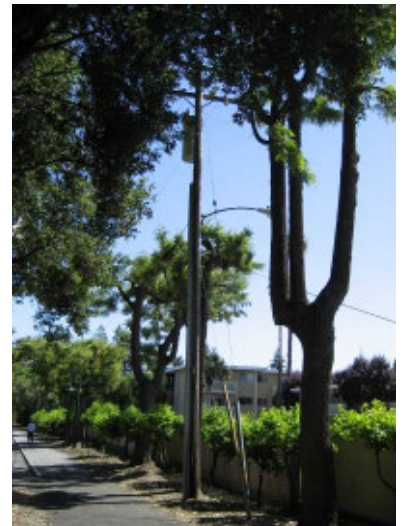
M23 **Power Pole**
